Appendix E

Primary System Leakage and Boric Acid Corrosion Operating Experience at U.S. Pressurized Water Reactors (1986-2002)

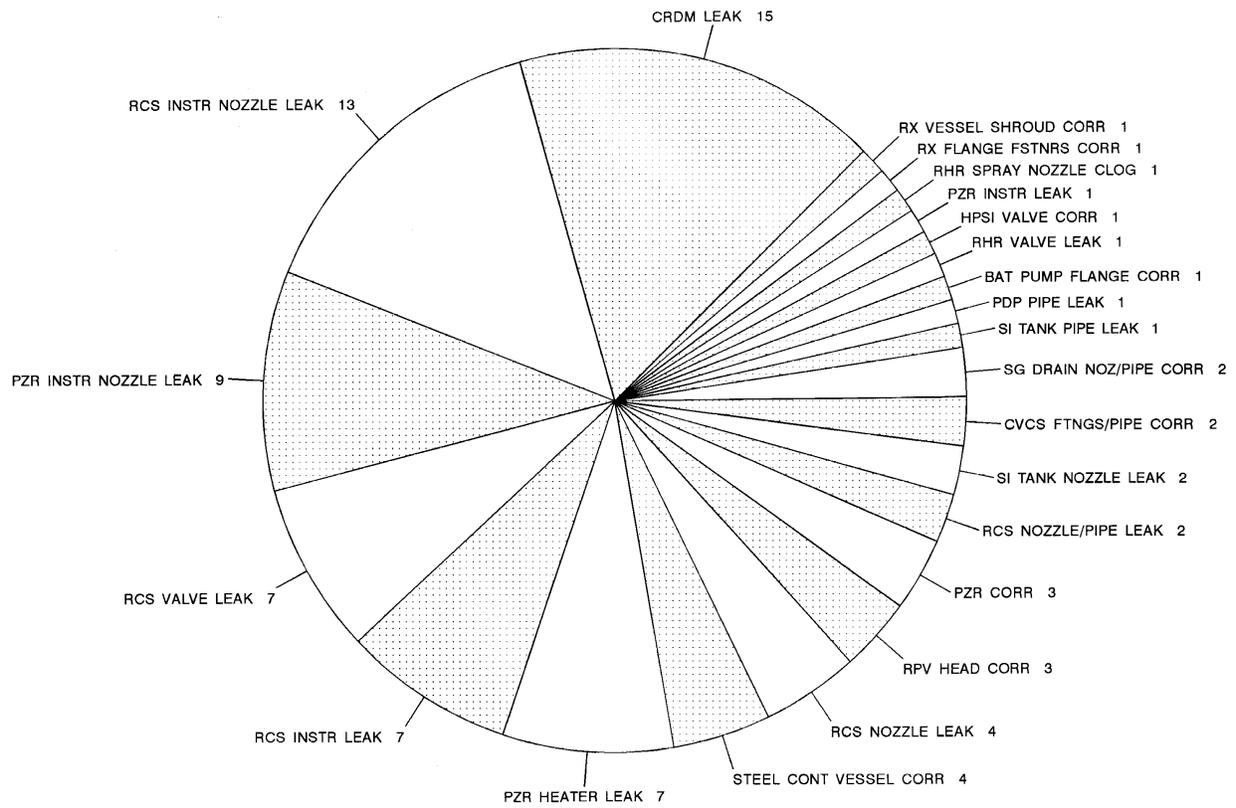
Figure E.2-1. Reported Areas Involving Boric Acid Leakage (1986-2002)

Figure E.2-1, "Reported Areas Involving Boric Acid Leakage (1986-2002)," lists each component that experienced a boric acid leak, or was affected by a boric acid leak. As the figure shows, the most prominent events involving boric acid leakage described in 15 documents related to control rod drive mechanism (CRDM) leaks, 13 related to reactor coolant system (RCS) nozzle leaks, 9 related to pressurizer (PZR) instrumentation nozzle leaks, and 7 each related to RCS valve leaks, RCS instrumentation leaks, and PZR heater sleeve leaks. Other less prominent events are described in four documents related to corrosion of the steel containment vessel, four related to RCS nozzle leaks, three events related to wastage of the RPV head, and three related to wastage of the PZR.

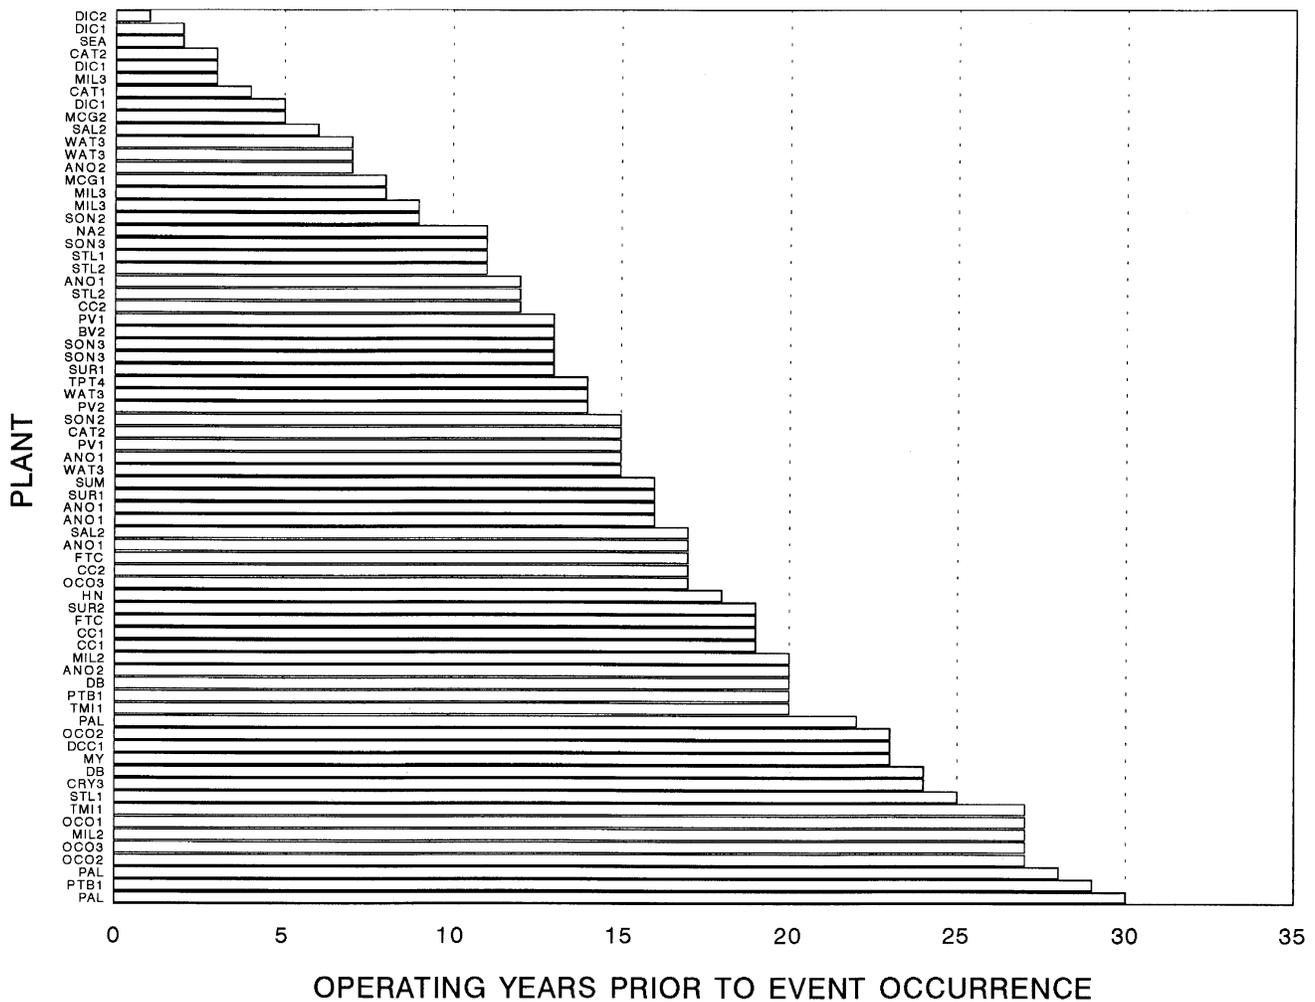
Figure E.2-2. Number of Operating Years Prior to Event Occurrence

Figure E.2-2, “Number of Operating Years Prior to Event Occurrence,” displays an even distribution of boric acid leakage events. This figure lists the plants that have reported a boric acid leak and the number of years of operation prior to the discovery of the leak. When these events are taken as a group, it appears that a plant is equally likely to experience a boric acid leak after only a few years of operation, as it is to experience a leak after a long period of operation. In general, however, smaller components take longer to develop leaks than do larger components. This observation is evident in subsequent figures.

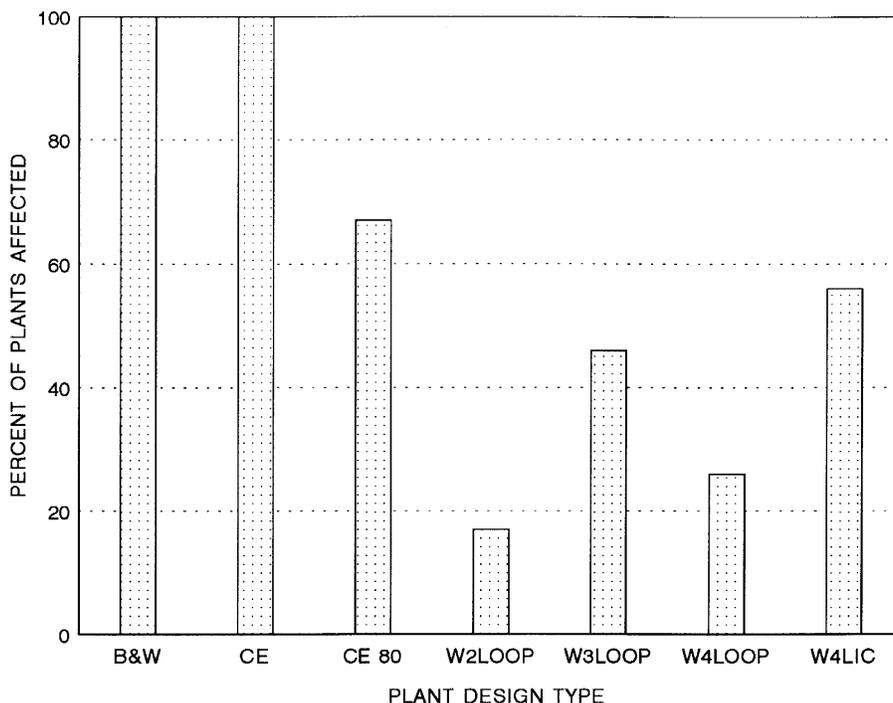
Figure E.2-3. Percent of NSSS Design Manufacturers Reporting Boric Acid Leakage

As shown in Figure E.2-3, "Percent of NSSS Design Manufacturers Reporting Boric Acid Leakage," Babcock & Wilcox (B&W) and Combustion Engineering (CE) plants appear to be highly susceptible to boric acid leakage and corrosion. In fact, 100 percent of B&W plants have reported boric acid related problems. Combustion Engineering plants were divided into the older CE plant design (12 units total) and the newer CE80 design (3 units total) to determine whether the designs exhibited any differences in susceptibility. As shown in the figure, 100 percent of the older CE plants reported boric acid leakage problems, while 67 percent of the CE80 design (two of three units) reported boric acid leakage problems.

Figure E.2-3 also shows that Westinghouse plants are less susceptible to boric acid leakage than other PWR designs. The Westinghouse group exhibited significant differences in operating experience. The older Westinghouse two-loop (W2LOOP) plants fared the best, with 17 percent (6 plants total) reporting boric acid leakage problems, while the four-loop ice condenser (W4LIC) version fared the worst, with 56 percent (9 plants total) reporting problems. Of the Westinghouse three-loop (W3L) plants, 46 percent (13 plants total) reported boric acid

leakage problems, while 26 percent (23 total) the four-loop (W4L) plants had reported boric acid leakage problems.

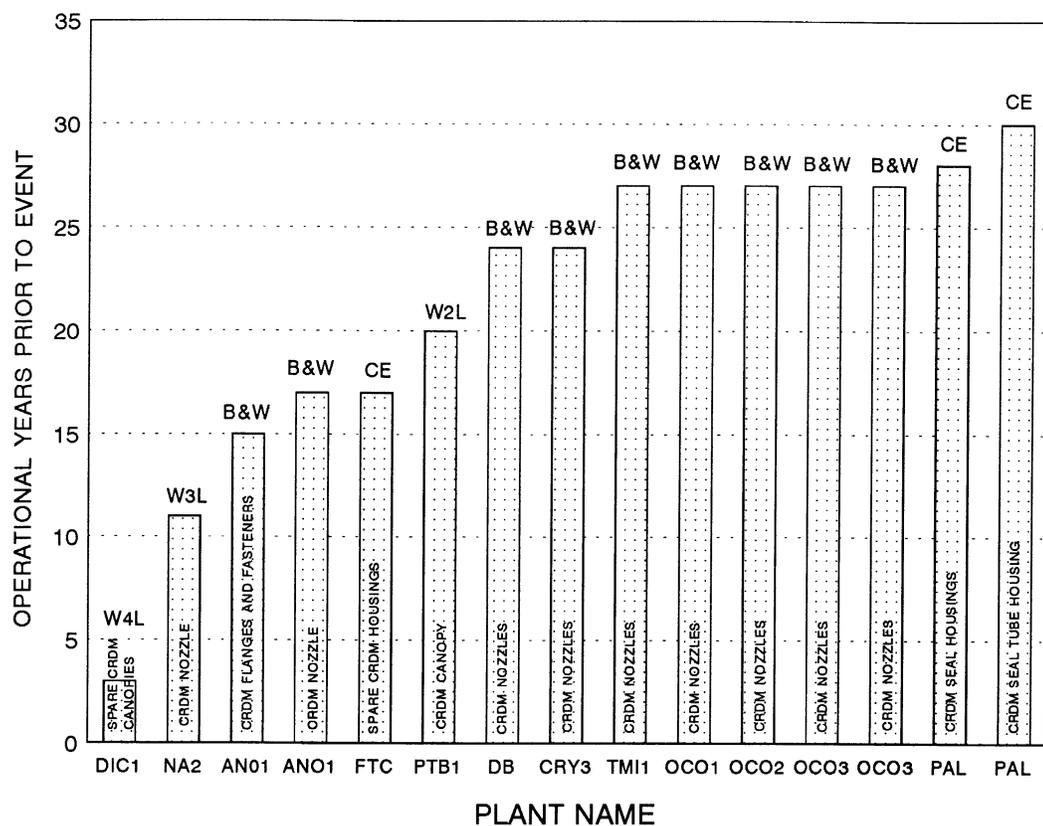
Figure E.2-4. Control Rod Drive Mechanism Leakage

As shown by Figure E.2-4, "Control Rod Drive Mechanism Leakage," B&W-designed plants dominate CRDM leakage. The task force reviewed 15 documents related to CRDM leakage, of which 9 described events that occurred at B&W plants. Considering that B&W plants make up less than 10 percent of the plants within the sample of 73 PWRs, the B&W plants are greatly over-represented. Figure E.2-4 shows the components that leaked, the specific facility experiencing the leakage, the design type of the plant, and the number of years of operation prior to the event being discovered. The types of boric acid leakage events include CRDM nozzles (dominant failure), spare CRDM canopies, CRDM seal housings, and a CRDM tube housing. Combustion Engineering is appropriately represented given that CE plants represent approximately 20 percent of the sample of 73 PWRs, and approximately 20 percent of the event reports (3 of 15 reports).

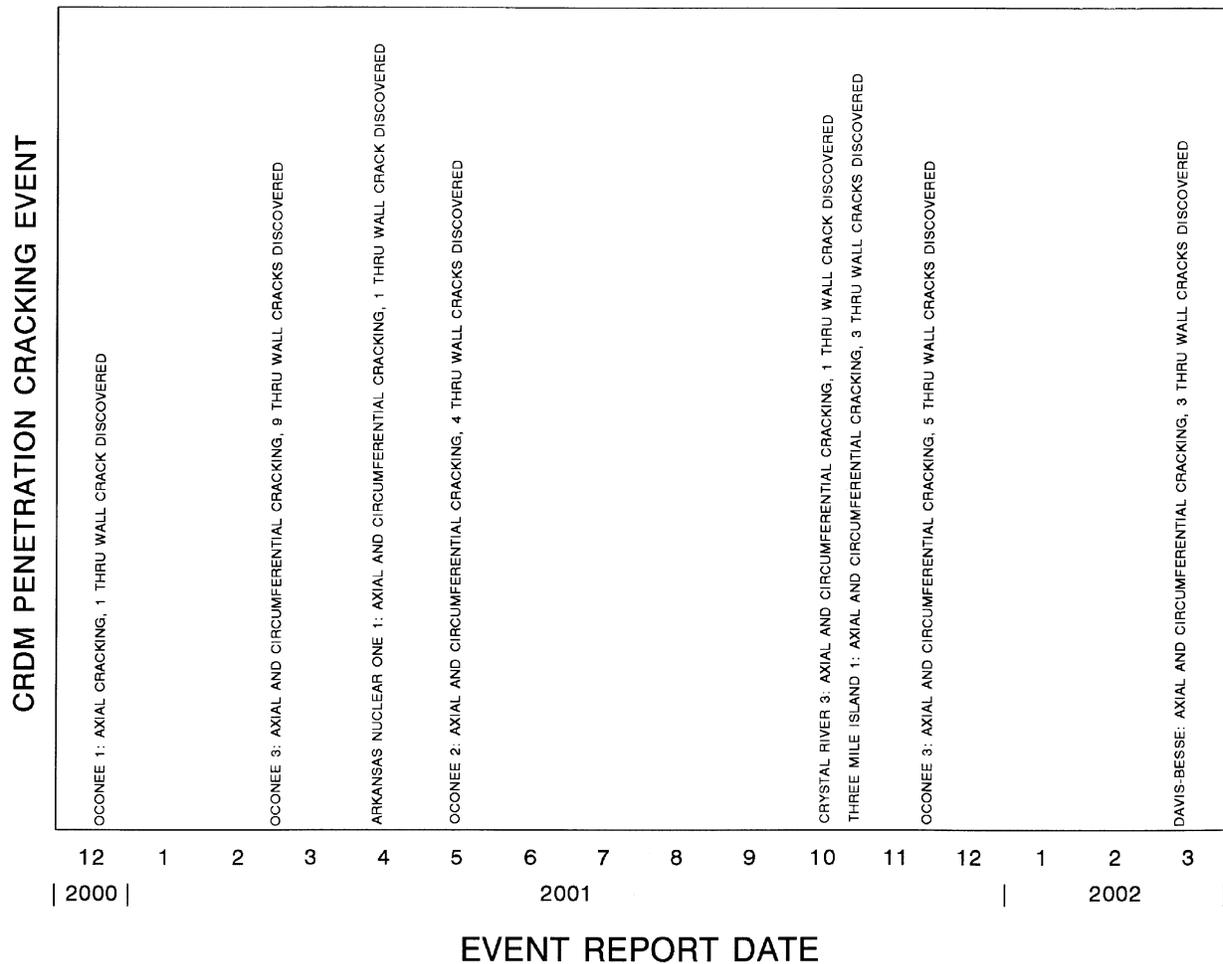
Figure E-2-5. VHP Nozzle Cracking Timeline for B&W Plants

Figure E.2-5, "Control Rod Drive Mechanism Penetration Cracking Timeline for B&W Plants," presents a graphical representation of CRDM penetration cracking for all B&W plants. As shown in the figure, DBNPS was the last B&W plant to report cracking.

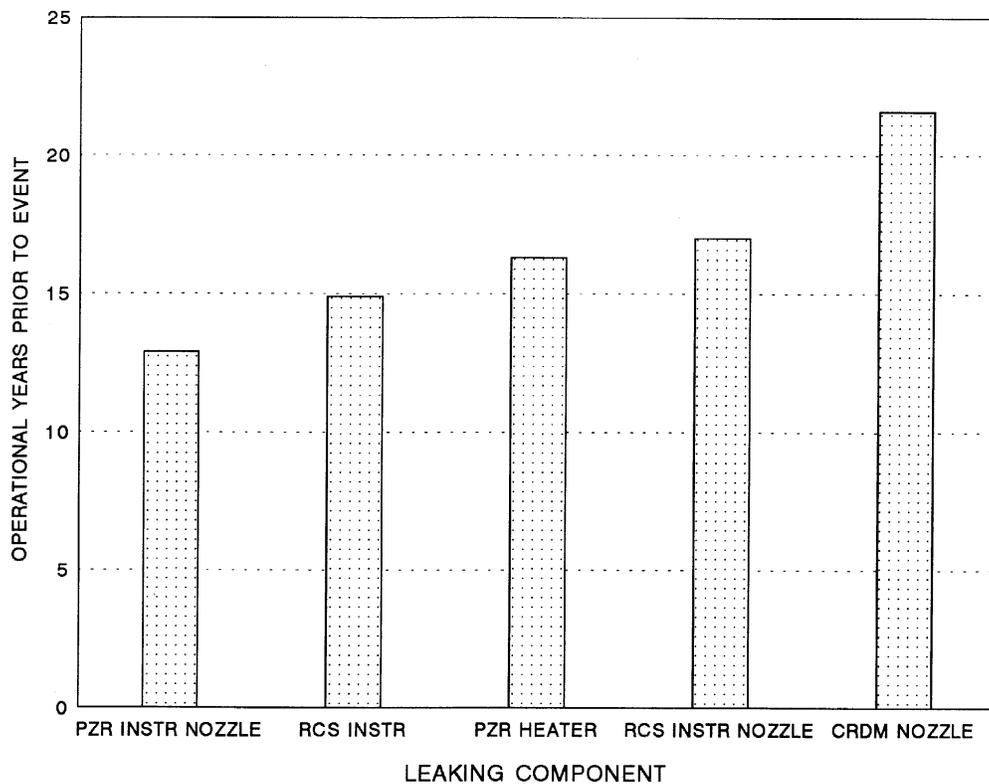
Figure E.2-6. Average Number of Operational Years Prior to Leakage Event for Selected Components

The task force reviewed operating experience to determine the average number of operating years prior to discovery of boric acid leakage problems. In doing so, the task force determined the operating time to leak discovery by comparing the event date with the date that the plant obtained its operating license from the NRC. Figure E.2-6, "Average Number of Operational Years Prior to Leakage Event for Selected Components," provides several insights regarding five of the most prevalent leakage areas, including CRDM nozzle leakage (15 reports), RCS instrumentation nozzles (13 reports), PZR instrumentation nozzles (9 reports), PZR heater sleeves (7 reports), and RCS instrumentation (7 reports). Most reports described multiple occurrences of leakage. These events and the operational experience to be gained were available to DBNPS. The licensee for DBNPS relied substantially on industry susceptibility models to postpone VHP nozzle inspections. As shown from the operational experience data, DBNPS was within the average operating time period to expect CRDM penetration cracking and leakage. The industry average operating time for CRDM penetration leakage is 21.6 years. The operating time period for DBNPS' discovery of leakage was 24 years, which exceeded the average time period.

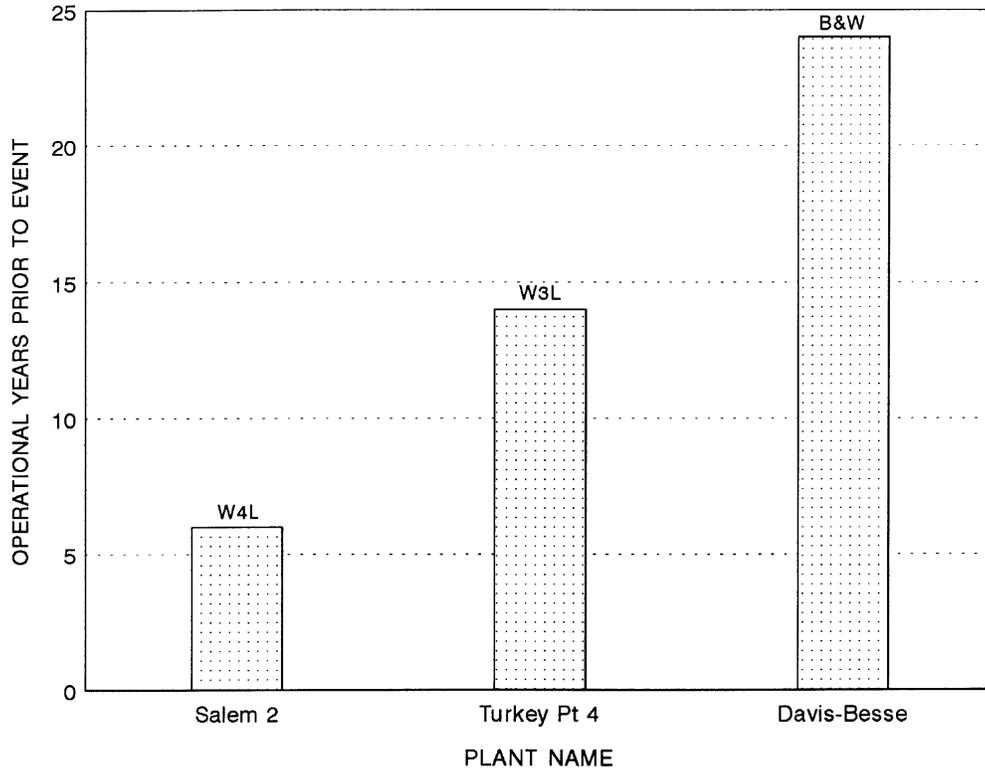
Figure 7. Reactor Pressure Vessel Head Base Metal Wastage Events

Figure E.2-7, "Reactor Pressure Vessel Head Base Metal Wastage Events," shows those plants that have experienced RPV corrosion (beyond surface metal corrosion). The figure also shows the operating years prior to event occurrence. The event at Turkey Point, Unit 4, in March 1987 was the major reason that the NRC issued IN 86-108, Supplement 1, in April 1987, and the event at Salem, Unit 2, in August 1987 was the major reason for issuing IN 86-108, Supplement 2, in November 1987.

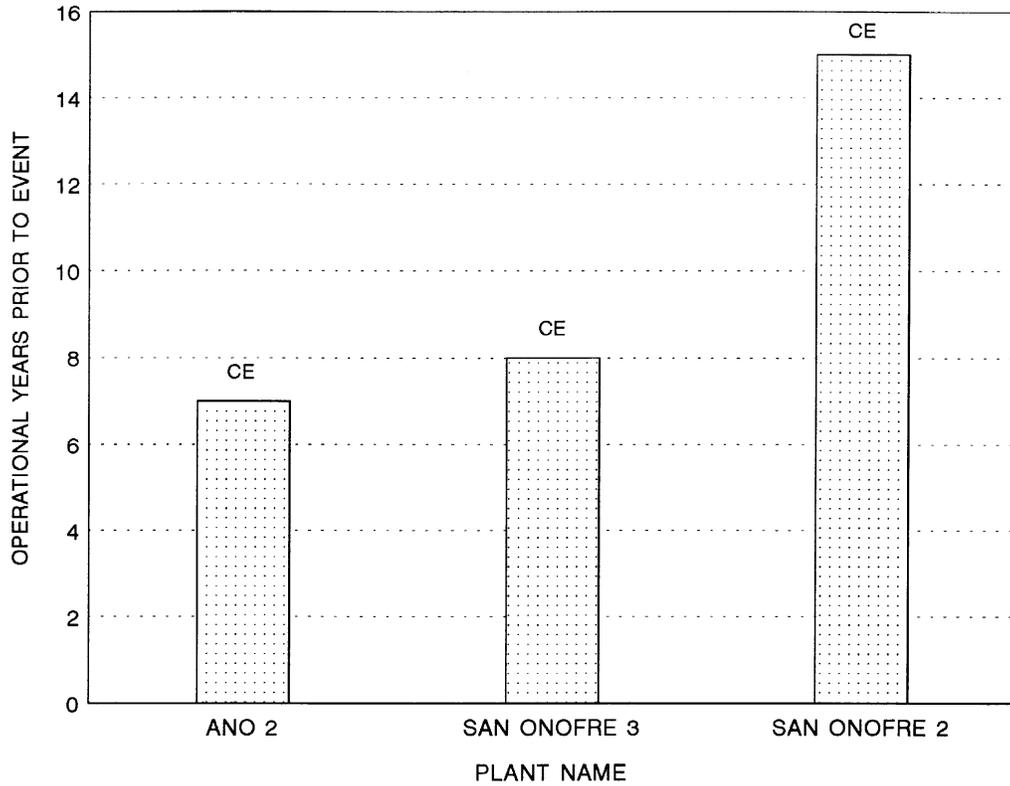
Figure 8. Pressurizer Vessel Base Metal Wastage Events

Figure E.2-8, "Pressurizer Vessel Base Metal Wastage Events," shows those plants that have experienced pressurizer vessel wastage (beyond surface metal corrosion). The figure also shows the number of operating years prior to event occurrence. These events, including their lessons learned, in conjunction with RPV wastage events indicate that boric acid corrosion of high-temperature components is possible, and should be assessed.

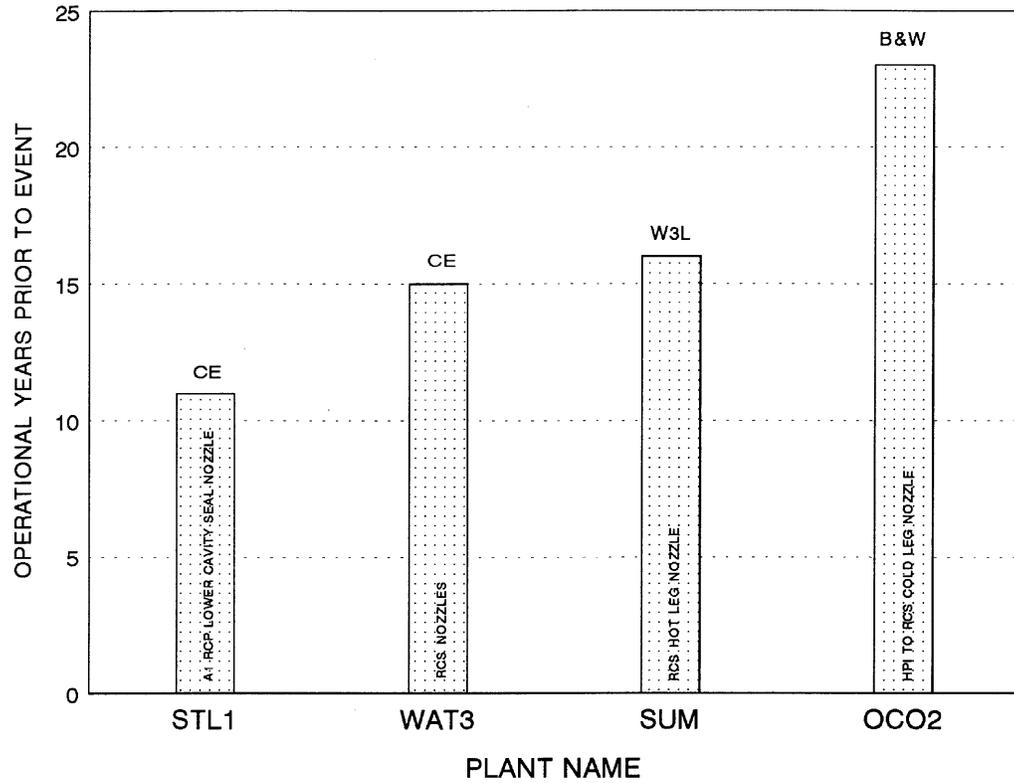
Figure 9. Reactor Coolant System Nozzle Leakage Events

Miscellaneous RCS nozzle leakage has occurred in varied locations. Figure E.2-9, "Reactor Coolant System Nozzle Leakage Events," shows that the larger nozzles take longer to develop leakage. The figure also shows that no one NSSS vendor dominates. Repetitive leakage from similar components is not evident.

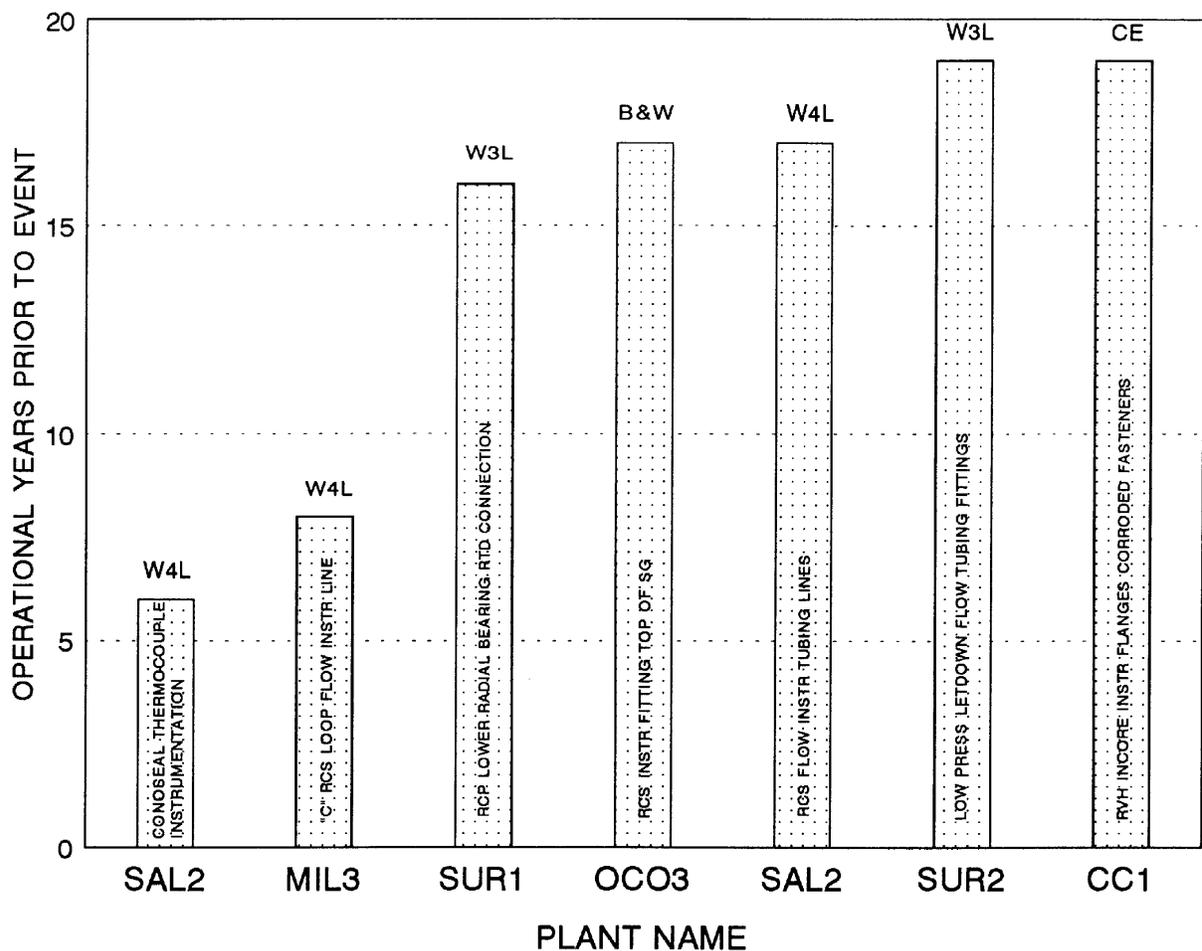
Figure E.2-10. Reactor Coolant System Instrumentation Leakage

Although RCS instrumentation leakage has occurred at B&W- and CE-designed plants, Westinghouse plants dominated with five out of seven recorded events. The recorded events do not indicate repetitive failures of similar components. Two of the events occurred at Westinghouse three-loop plants, while three events occurred at Westinghouse four-loop plants. See Figure E.2-10, "Reactor Coolant System Instrumentation Leakage," for a brief description of the event and the number of years of operation prior to each. Notably, five of the seven events occurred after 15 to 20 years of operation.

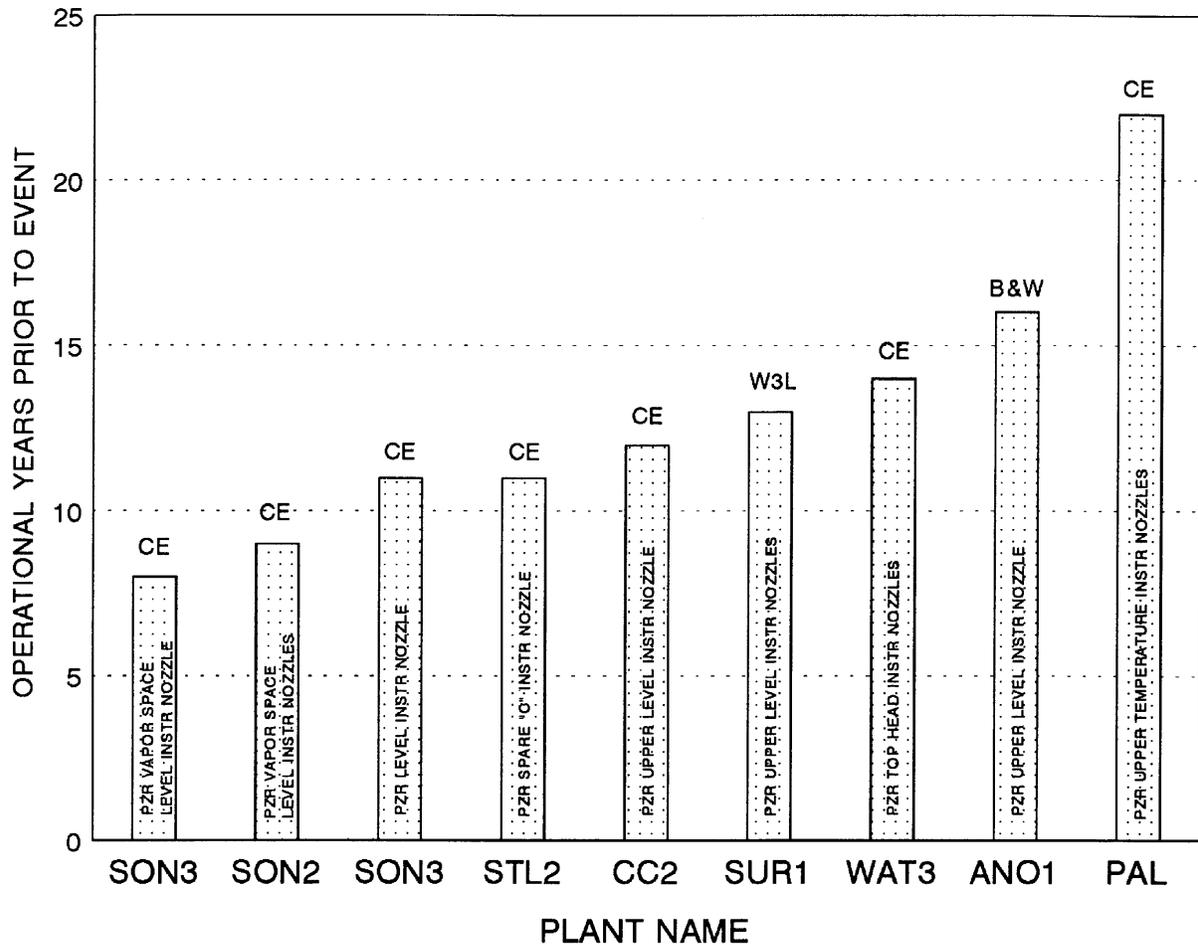
Figure E.2-11. Pressurizer Instrumentation Nozzle Leakage

As shown in Figure E.2-11, "Pressurizer Instrumentation Nozzle Leakage," CE plants dominate the recorded events. Seven of nine PZR instrumentation nozzle leakage events occurred at CE plants. Most of the events involved PZR level instrumentation. Most (five of nine) of the PZR instrumentation events occurred between 11 and 14 years of operation.

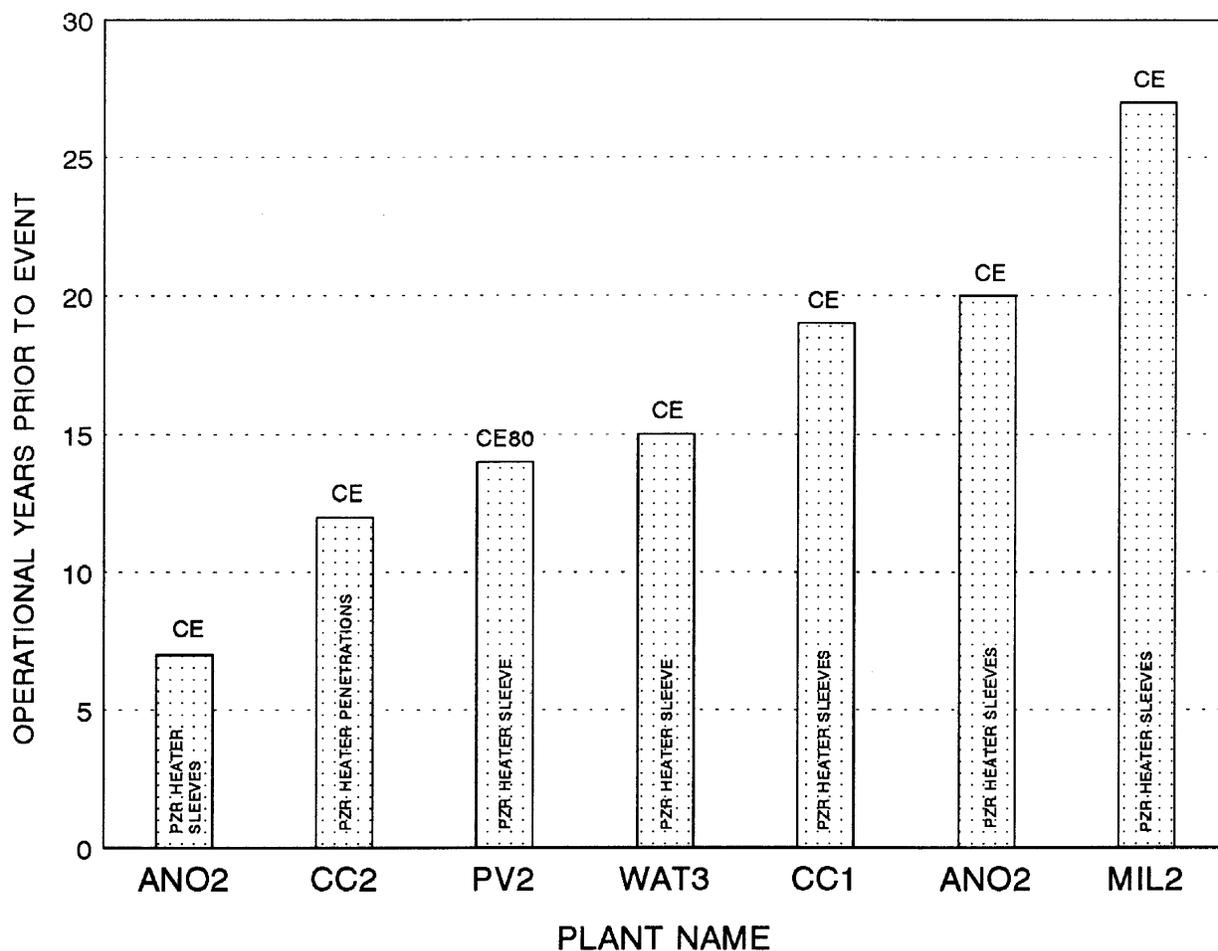
Figure E.2-12. Pressurizer Heater Sleeve Leakage

Figure E.2-12, "Pressurizer Heater Sleeve Leakage," shows that CE plants dominated the recorded events, comprising 100 percent (seven of seven) of the events. The event at Calvert Cliffs, Unit 2, was extensive, involving 28 of 120 leaking sleeves. Leaking boric acid from the Calvert Cliffs event also resulted in corrosion damage to the carbon steel base metal of the PZR. Other events involving PZR heater sleeves were less severe.

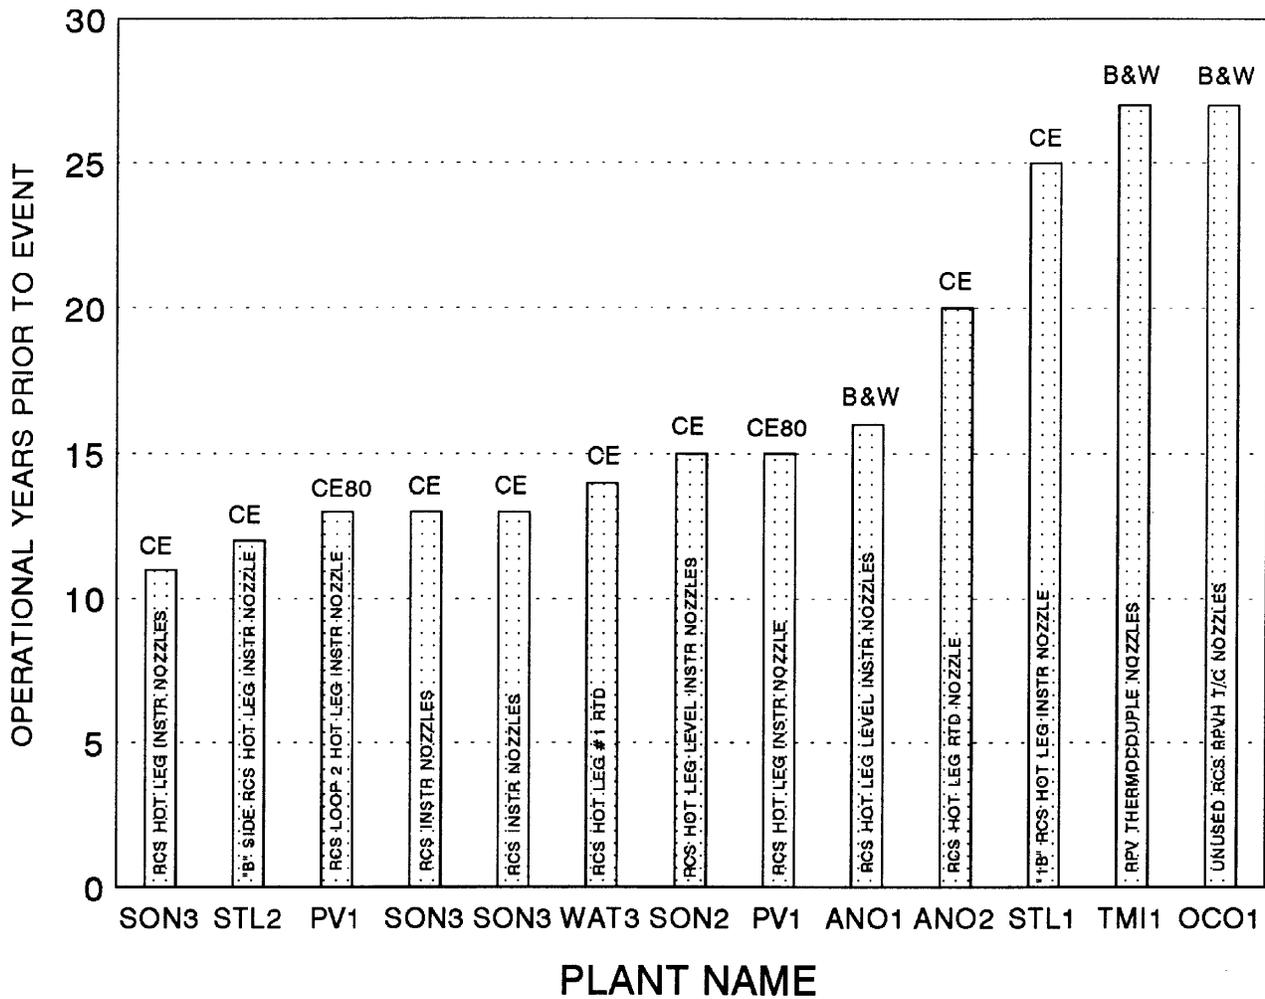
Figure E.2-13. Reactor Coolant System Instrumentation Nozzle Leakage Events

As shown in Figure E.2-13, "Reactor Coolant System Instrumentation Nozzle Leakage Events," CE plants dominated the recorded events, representing 9 of 13 events. In addition, most of the events involved more than one leaking nozzle. The review also shows that most of the events involved hot leg nozzles. Of the 13 instrumentation nozzle events, 9 occurred between 11 and 16 years of operation. Most of the nozzle cracking was attributed to primary water stress corrosion cracking (PWSCC).

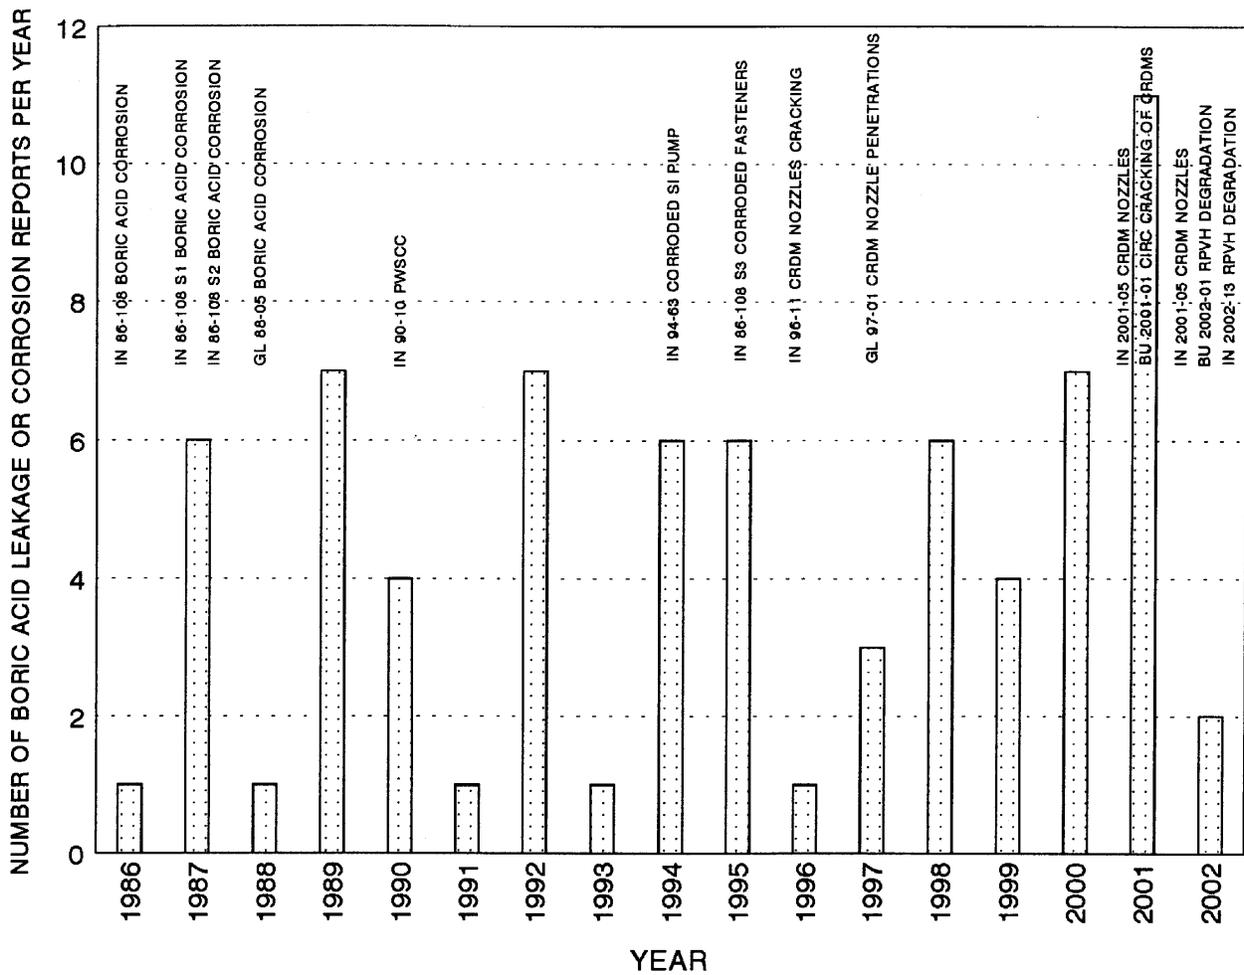
Figure E.3-1. Boric Acid Leakage and Corrosion Events Versus Relevant NRC Generic Communication Documents

Figure E.3-1, “Boric Acid Leakage and Corrosion Events Versus Relevant NRC Generic Communication Documents,” shows that several years elapsed (with relatively high numbers of primary system leakage or boric acid corrosion events) during which the NRC did not issue any generic communications related to boric acid leakage or corrosion. For example, during the period from 1989 through 1994, the NRC issued two INs (IN 90-10 on PWSCC of Alloy 600, and IN 94-63 on boric acid corrosion of a pump casing). In addition, during the period from 1998 through 2000, plants experienced instances of RCS nozzle leakage without the NRC issuing any related generic communication.
